# Habitat

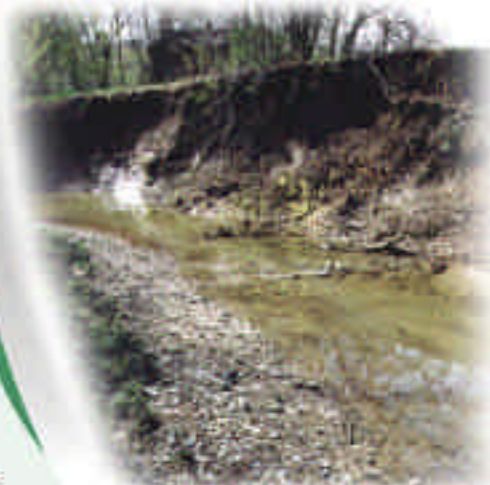
*Kinnickinnic River eroding stream bank.*

With human activity comes an increase in hard (impervious) surfaces (i.e., rooftops and roadways). Hard surfaces increase runoff, pollutants, and the risk of flooding. Flooding can damage streambeds and banks, causing the river's natural channel to become unstable. As a heavily urbanized watershed, the Kinnickinnic River Watershed contains many streams that have been straightened, deepened and routed into concrete channels. Past attempts to manage flooding in the Kinnickinnic River Watershed eliminated habitats within and along its waterways. However, recent efforts have been initiated to study the removal of the concrete from portions of the Kinnickinnic River, yet still provide flood protection. New stormwater runoff rules are helping curb the amount of new runoff reaching the Kinnickinnic River and its tributaries.

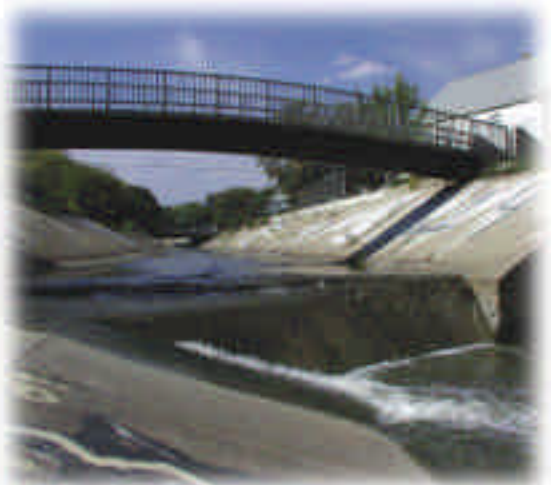
*Kinnickinnic River concrete-lined channel, 9th Street.*

Habitat is severely limited throughout the Kinnickinnic River Watershed. The Kinnickinnic River mainstem between 43rd Street and 6th Street and many of its tributary streams have been channelized or concrete lined for flood management purposes. Substantial sections of Wilson Park Creek and 43rd Street Ditch are also contained in buried concrete conduits. Current efforts are underway to study the feasibility of removing concrete from portions of the Kinnickinnic River and still maintain flood protection.
