Habitat Map

Menomonee River Watershed

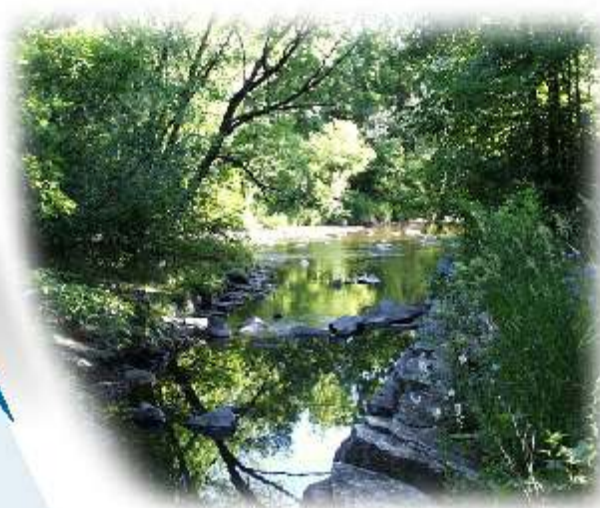
Natural channels

- **Stable natural banks.**
- **Natural vegetative cover and tree canopy that provides stream shading.**
- **Streambed not heavily covered over with silt and muck.**
- **Diverse stream structure that has riffle areas and pools for fish refuge.**
- **Wide vegetated buffer area along waterway that filters out polluted stormwater runoff.**

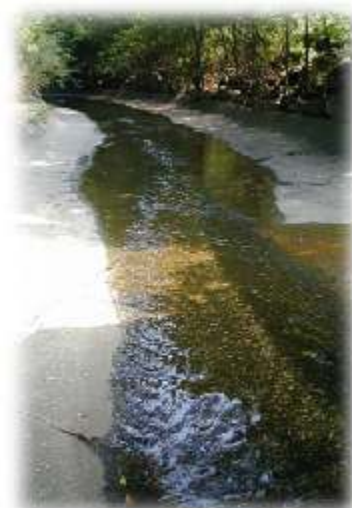
Concrete lined channels

With human activity comes an increase in hard (impervious) surfaces (i.e., rooftops and roadways). Hard surfaces increase runoff, pollutants, and the risk of flooding. Flooding can damage streambeds and banks, causing the river's natural channel to become unstable. Past attempts to manage flooding in the Menomonee River watershed led to streambeds and banks being channelized (straightened and deepened) and lined with concrete. This process eliminated habitats within and along waterways. As a rapidly urbanizing watershed, the Menomonee River Watershed contains many streams that have been ditched, straightened, or routed into concrete channels. However recent efforts have been initiated to remove concrete from the Menomonee River and many flood management projects are under way that include stormwater runoff rules and conservation of open land.

Habitats are in better condition along the northern-most half of the Menomonee River Watershed, but begin to deteriorate as the river winds into more urban areas. Portions of the Little Menomonee River are heavily silted in and large sections of Underwood and Honey Creeks are concrete-lined.
