**Subject:** September 13-14, 2019 Combined Sewer Overflow Event Five-Day Notification Letter  
WPDES Permit No. WI-0036820-04-0

**Milwaukee Metropolitan Sewerage District**

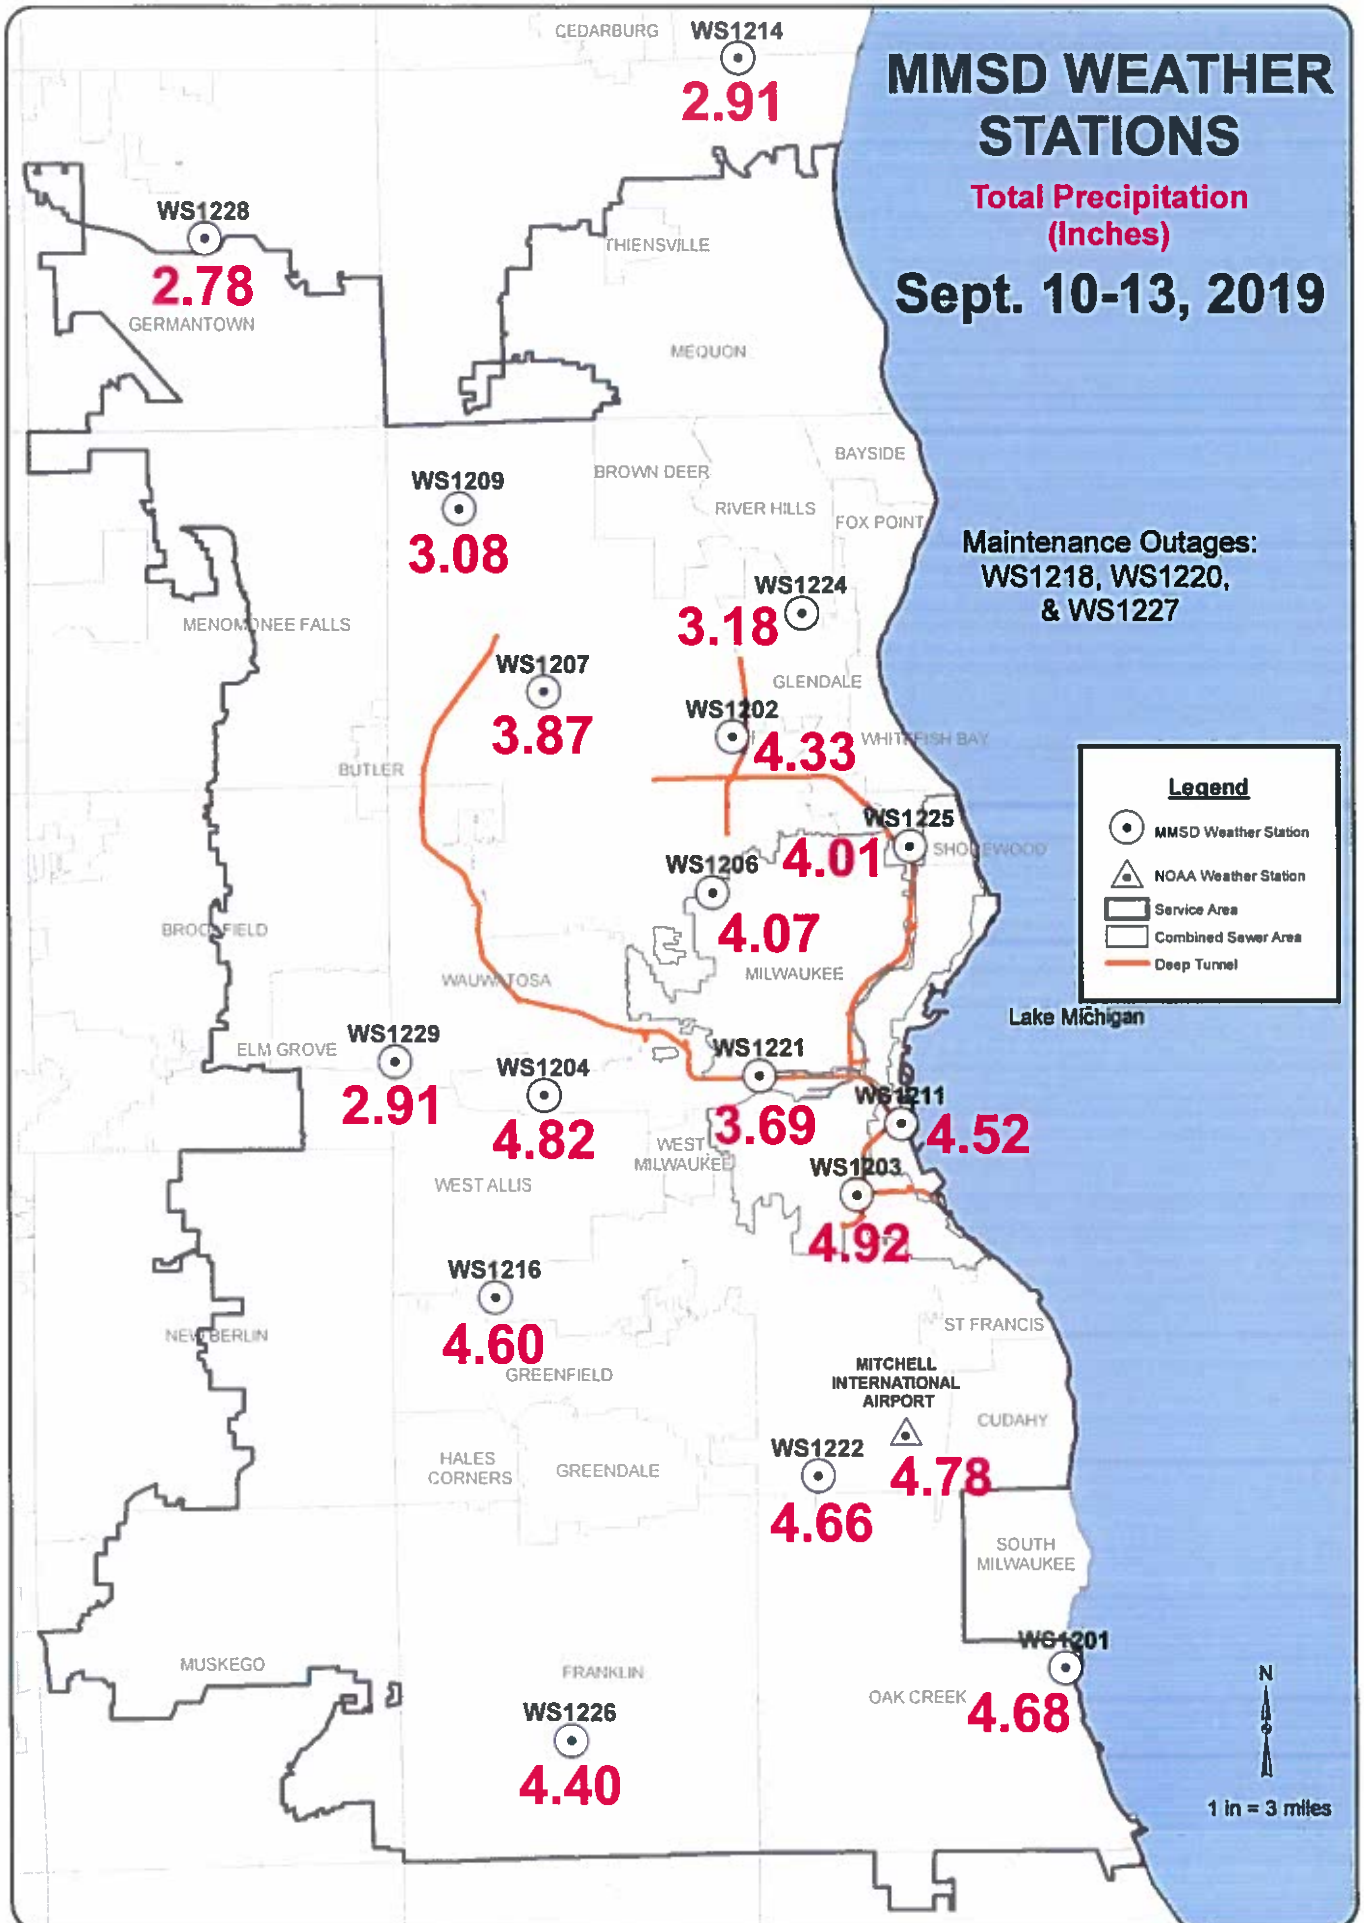
# MMSD WEATHER STATIONS

Total Precipitation  
(Inches)

Sept. 10-13, 2019

Maintenance Outages:  
WS1218, WS1220,  
& WS1227
